2-story residence, Riverdale, New Jersey

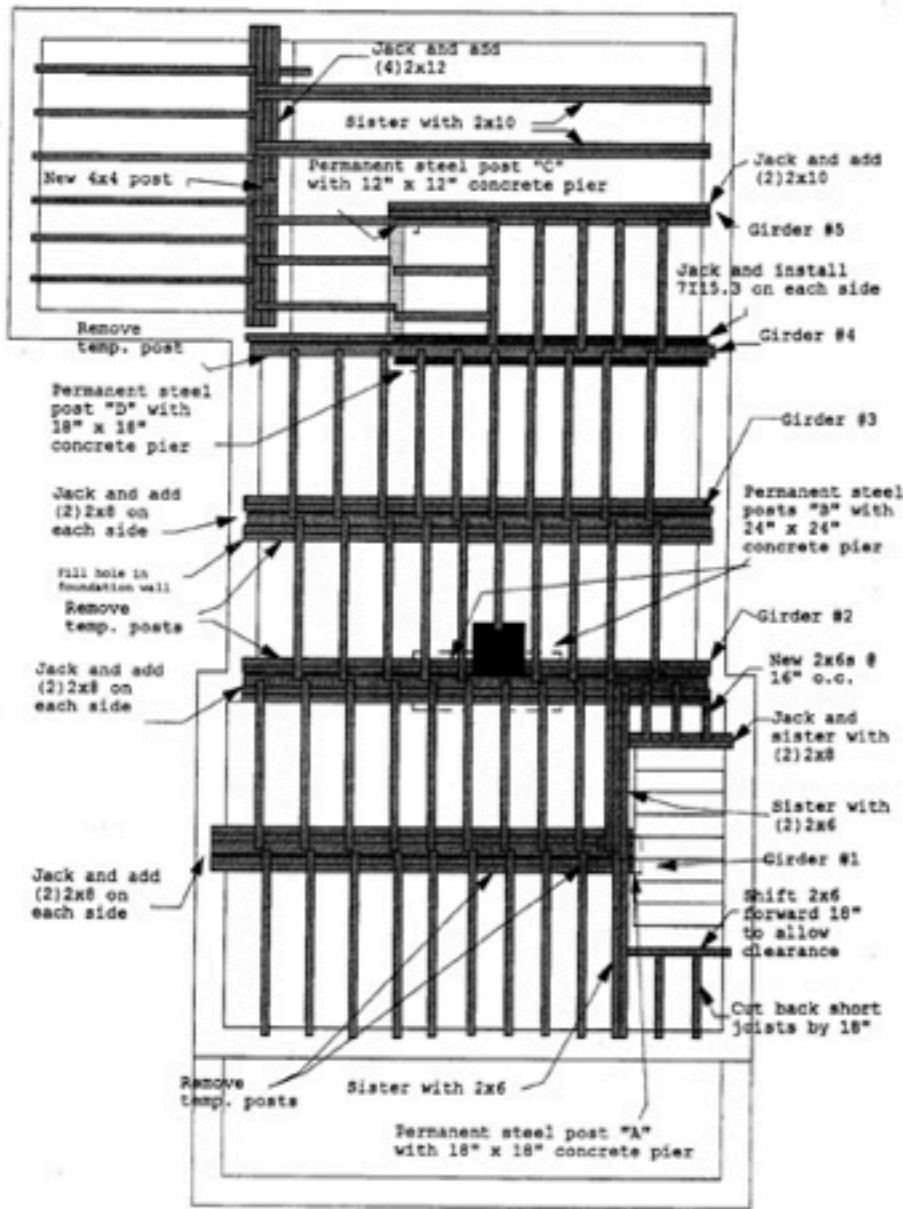
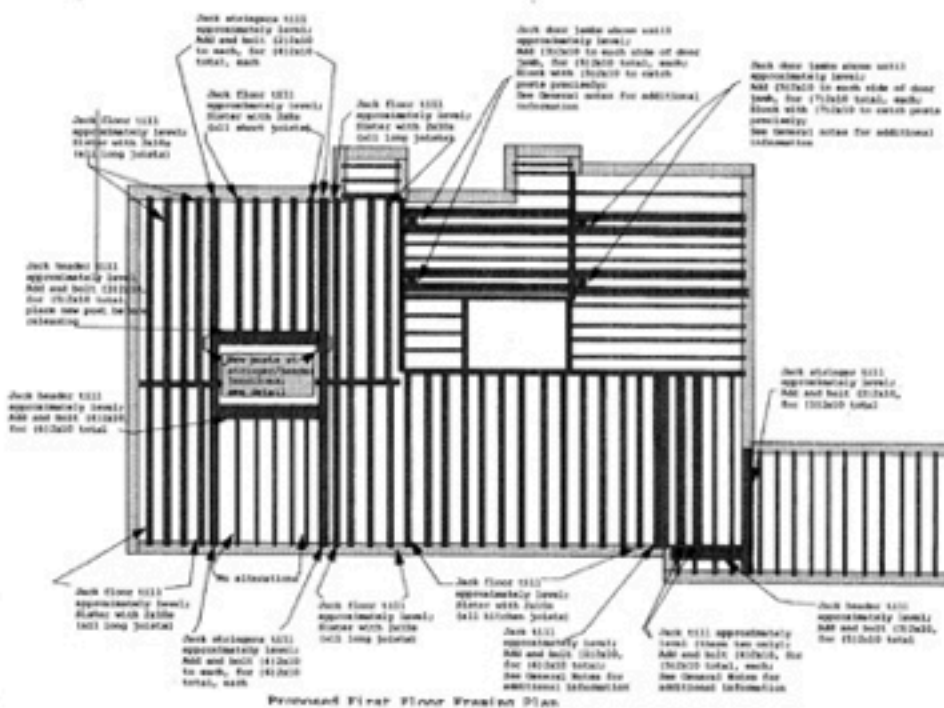
Problem: First and second floors partially failed and deflected up to 4 inches.

Solution: Design and installed reinforcement of all girders and joists, avoiding probable demolition. Restored floors to near-original levels.
