2-1/2-story commercial building, Morristown, New Jersey

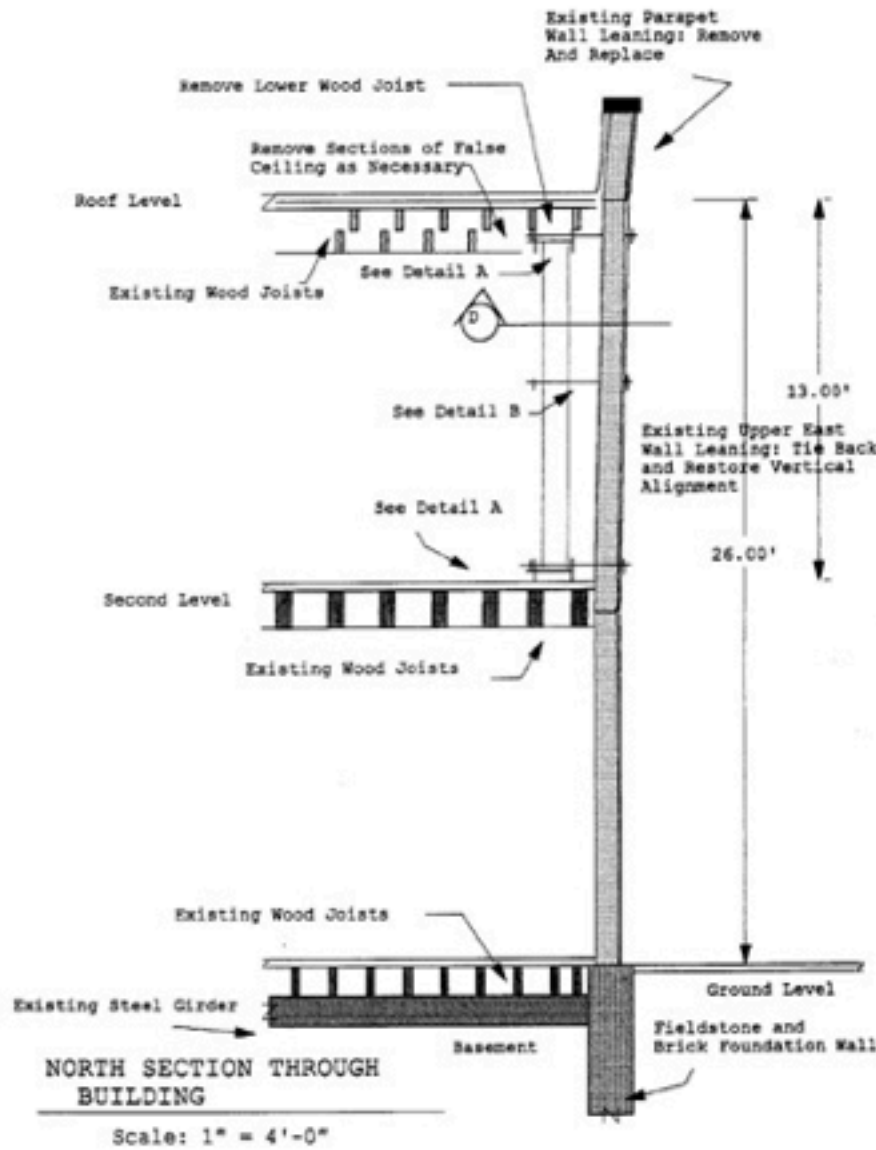
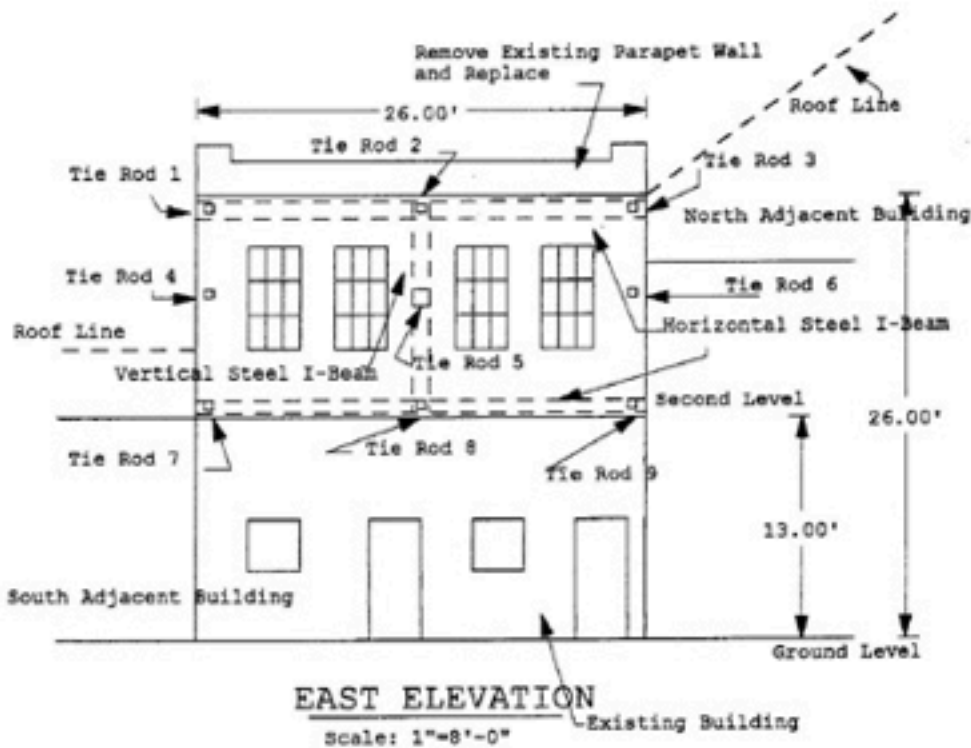
Problem: Front masonry wall leaning 5 inches toward the street.
Solution: Designed and built interior steel frame to restore wall to its original position.
