**2-1/2-story residence, Green Village, New Jersey**

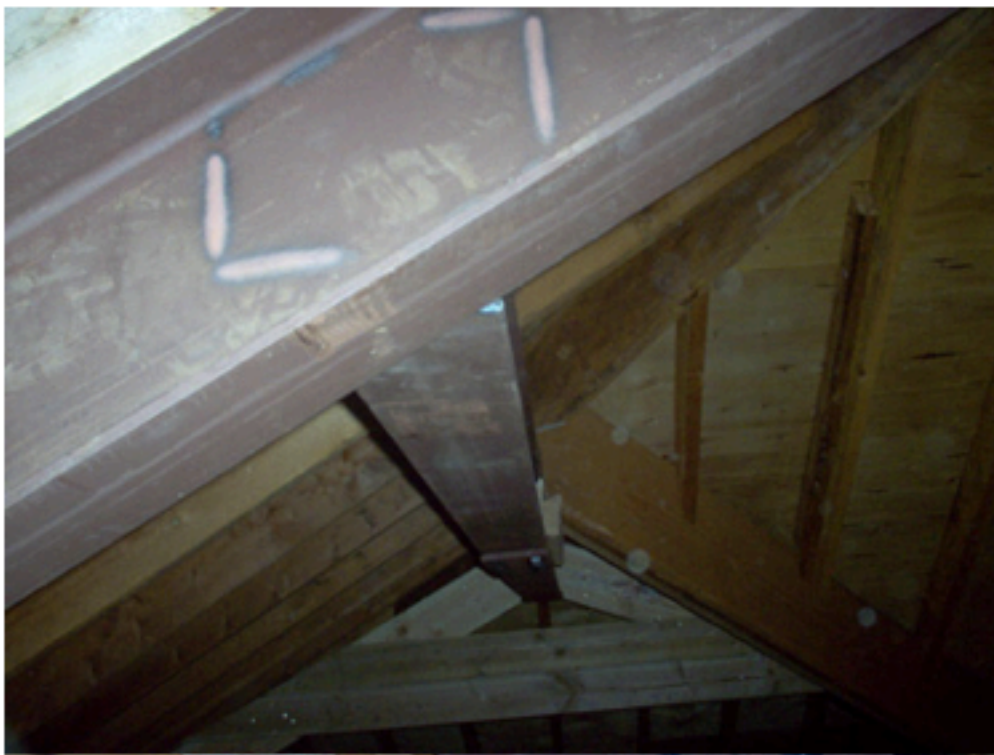
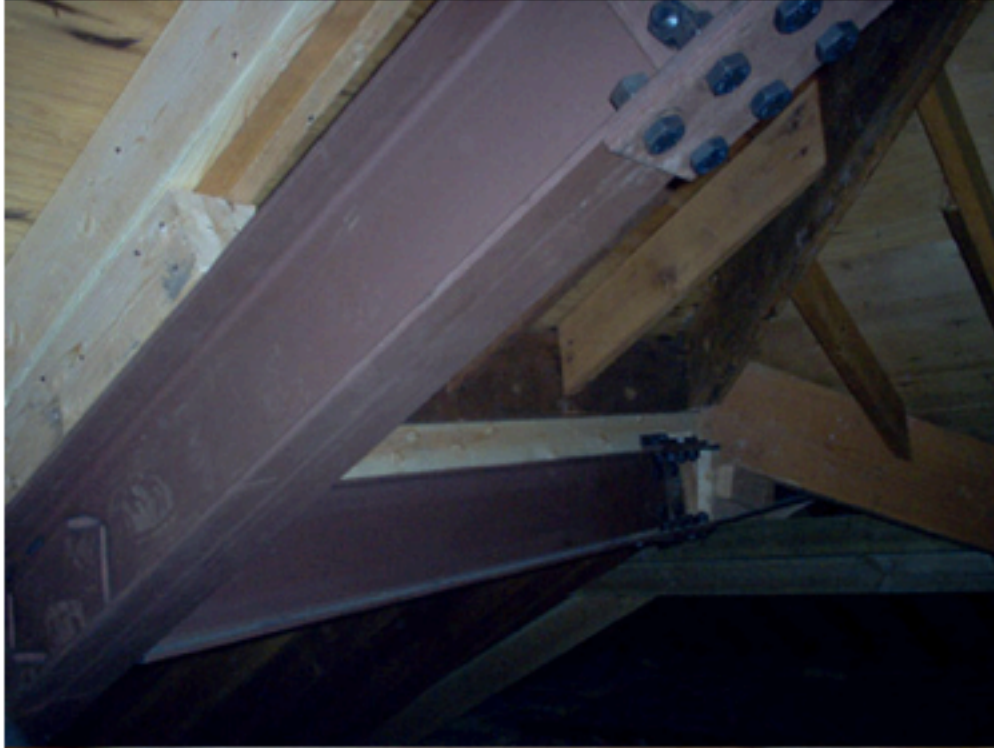
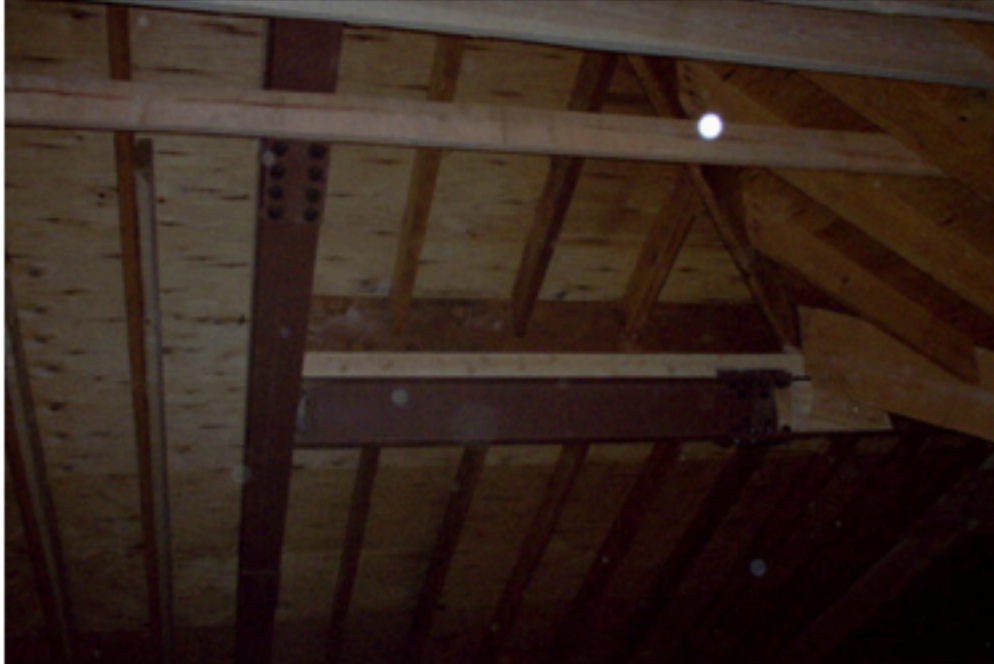
**Problem:** Posts supporting the roof causing the interior frame to deflect.

**Solution:** Designed and built supplementary attic frame allowing posts to be eliminated.
