3-story landmark barn converted to office and retail space

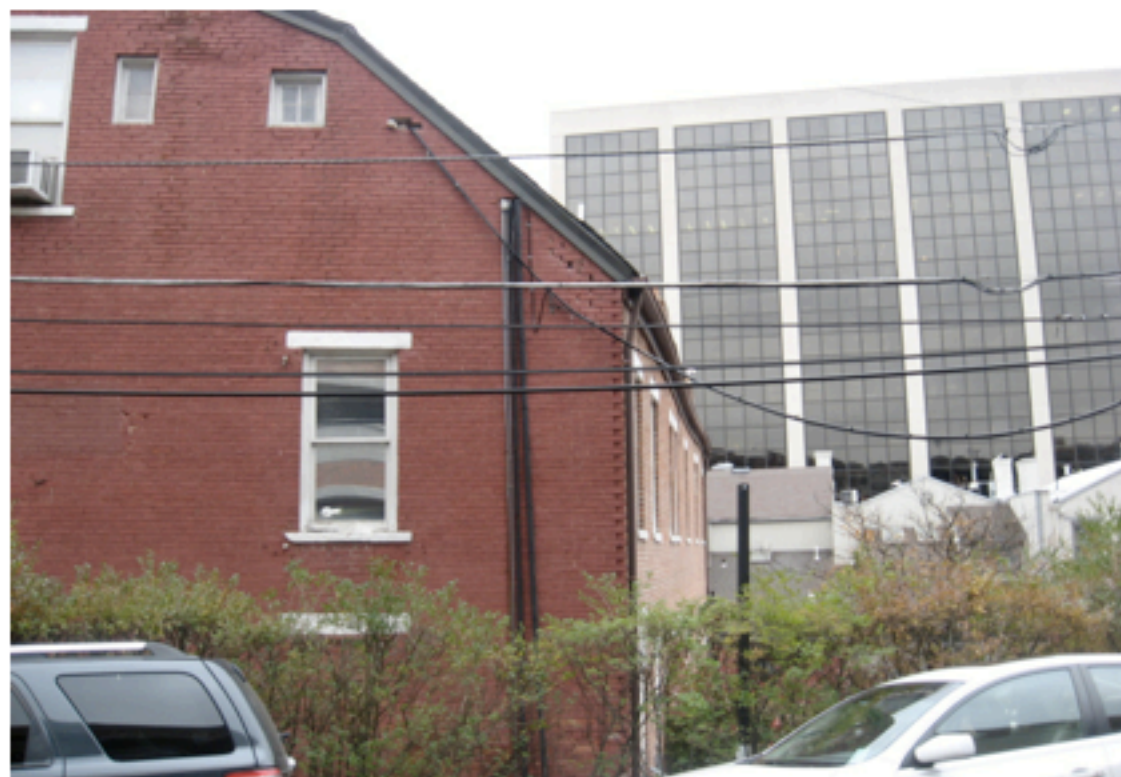
Problem: Truss system supporting roof and top level failed.

Solution: Designed and installed steel cable tie system to relieve thrust from exterior walls.
